Evaluation of Precast Panels for Airfield Pavement Repair

Phase II: Results of Accelerated Pavement Testing

Lucy P. Priddy, Peter G. Bly, Christopher J. Jackson,
and Tony N. Brogdon

September 2013

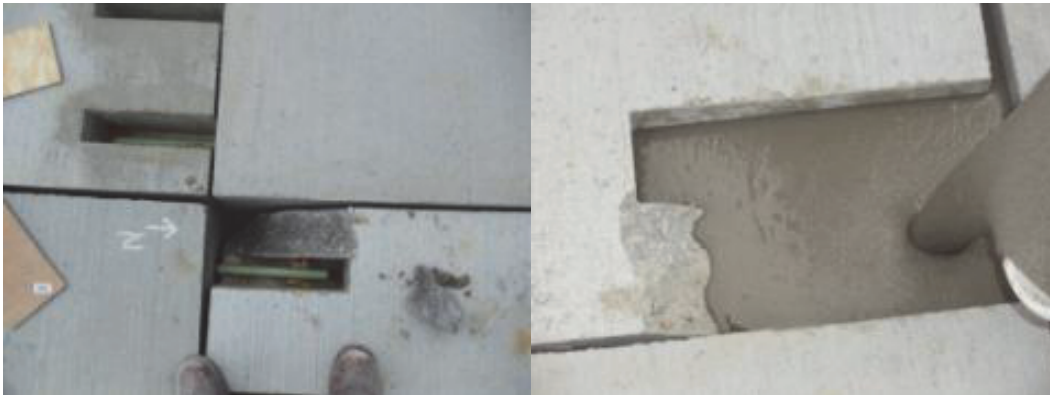
Figure 11. Damaged and repaired dowel bar receptacle on panel 4.

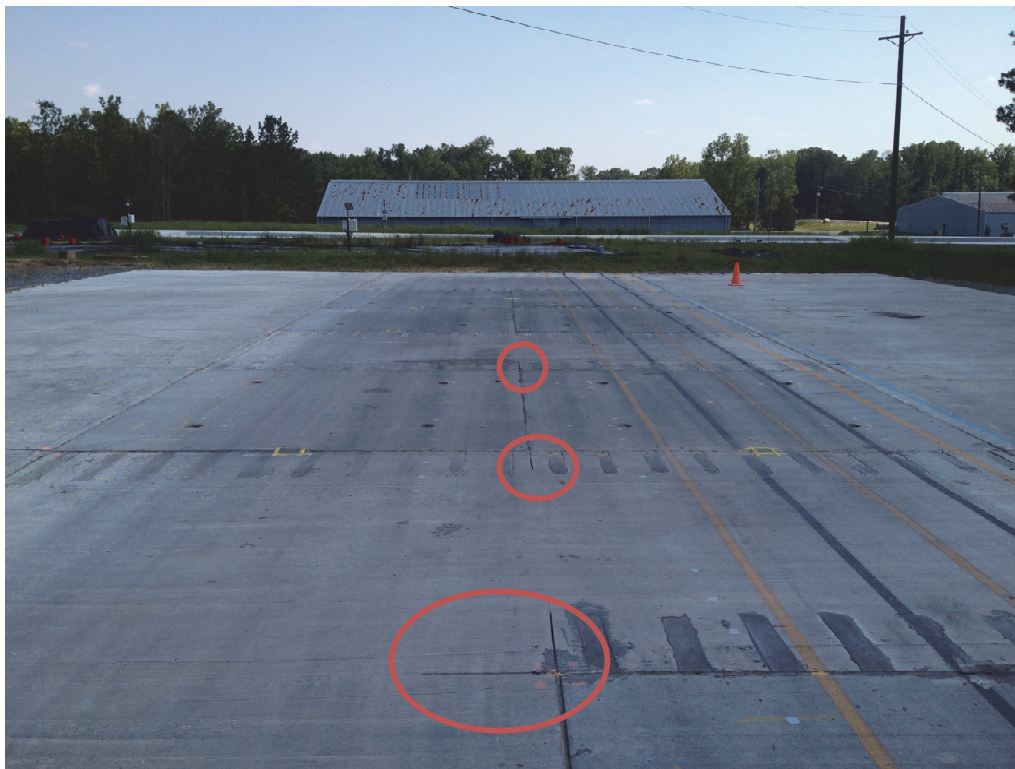
Additionally, when the test section was saw cut to generate the repair areas, overcuts (kerfs) from the corners of the repairs extended approximately 12 to 15 in. into the parent PCC (Figure 12). This overcutting was necessary to provide the full depth cut using a round saw blade to fully free the demolished concrete. During trafficking, cracks extended from these overcuts.

Figure 12. Saw cuts at corners of panels.

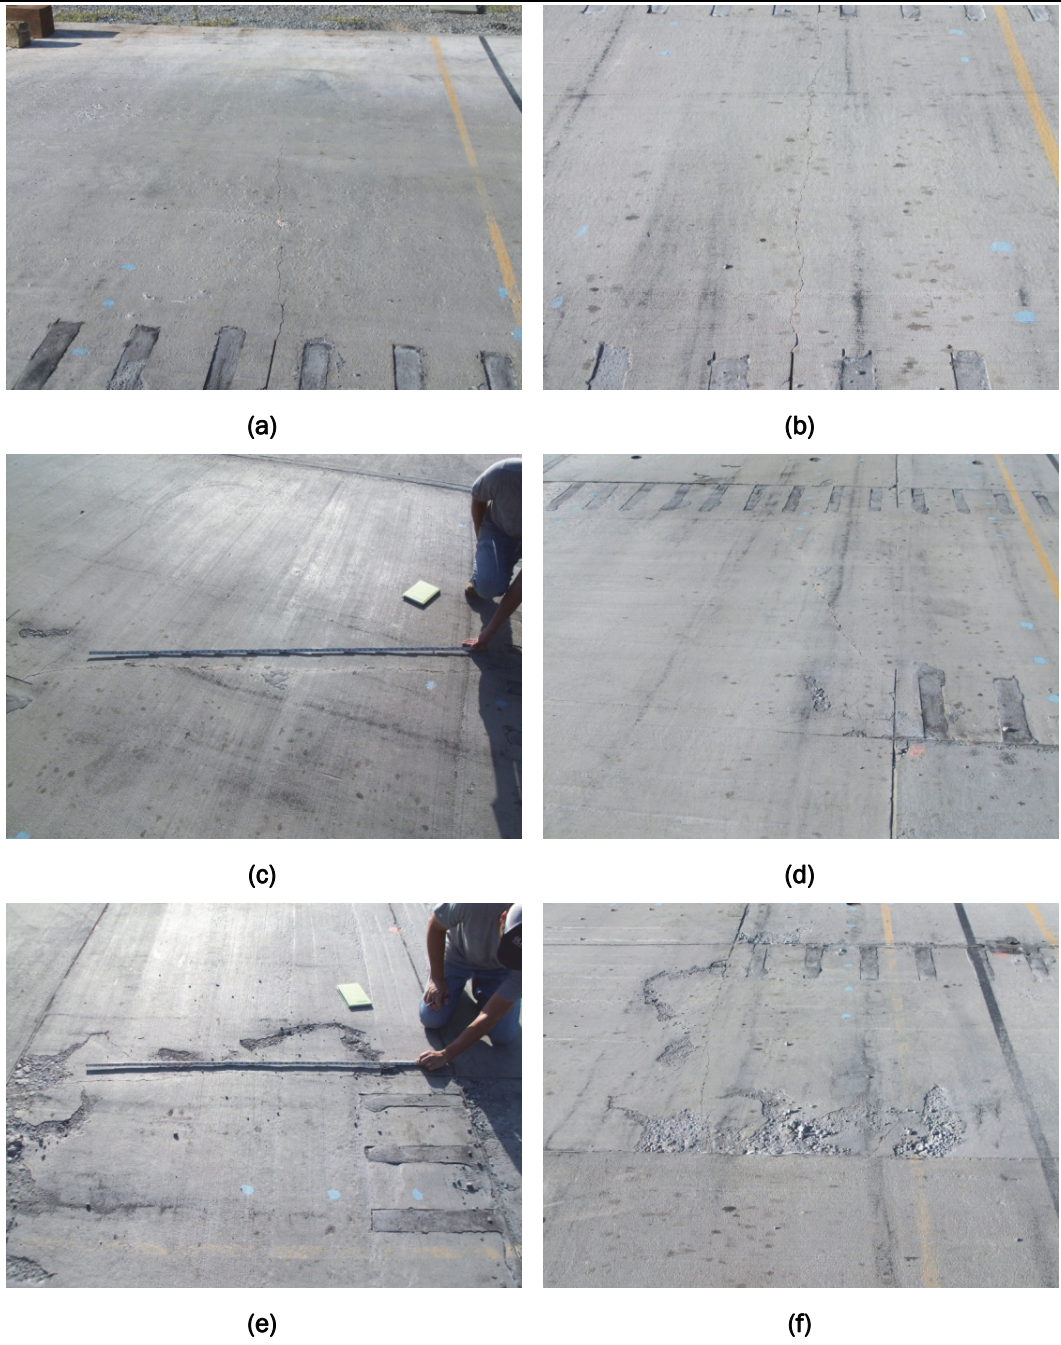
Figure 13. Parent slab distresses after 2,800 passes: (a) longitudinal crack in parent slab south of Repair 2 extending from saw undercut; (b) longitudinal crack in parent slab between Repairs 2 and 3 extending from saw undercut; (c) diagonal crack in parent slab extending from NE edge of Repair 1 extending from saw undercut; (d) diagonal crack in parent slab from SE edge of Repair 1 to Repair 2 extending from saw undercut and spalling and cracking between saw overcuts on SE corner of Repair 1; (e-f) spalling and cracking in parent slab north of Repair 1 near construction cold joint.

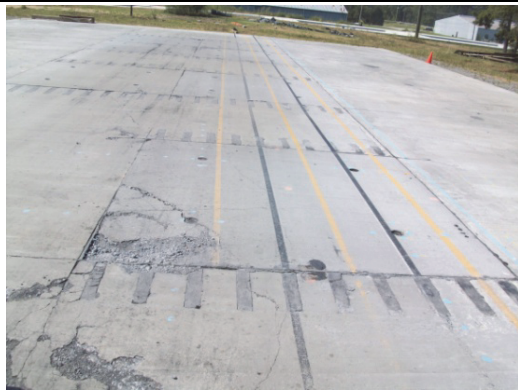
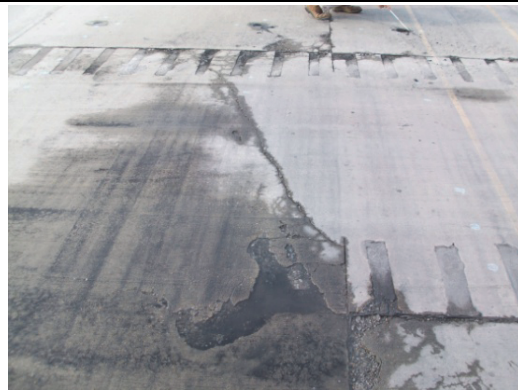
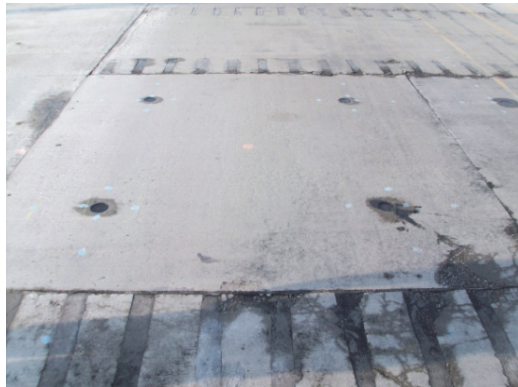
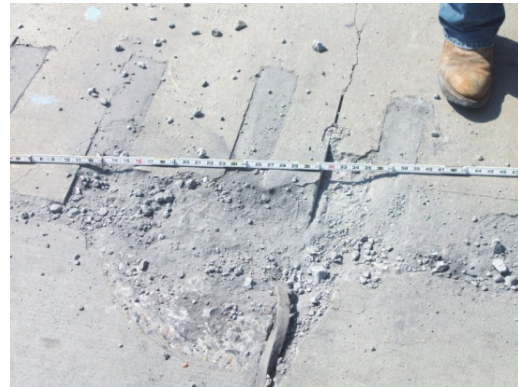
Figure 14. Repair failure details: (a) Repair 1-Panel 1: high-severity corner break/spall and shattered parent slab; (b) Repair 2: diagonal cracking in parent slab between Repairs 1 and 2 and cracking and spalling of Panel 2 due to the parent slab deterioration; (c) close-up of the cracking and deterioration in the parent slab and dowel slots and corner of Panel 2; (d) Repair 3 Panels 6 and 7: high-severity spalling in corner of Panels 6, 7, and the parent slabs south of the repair.

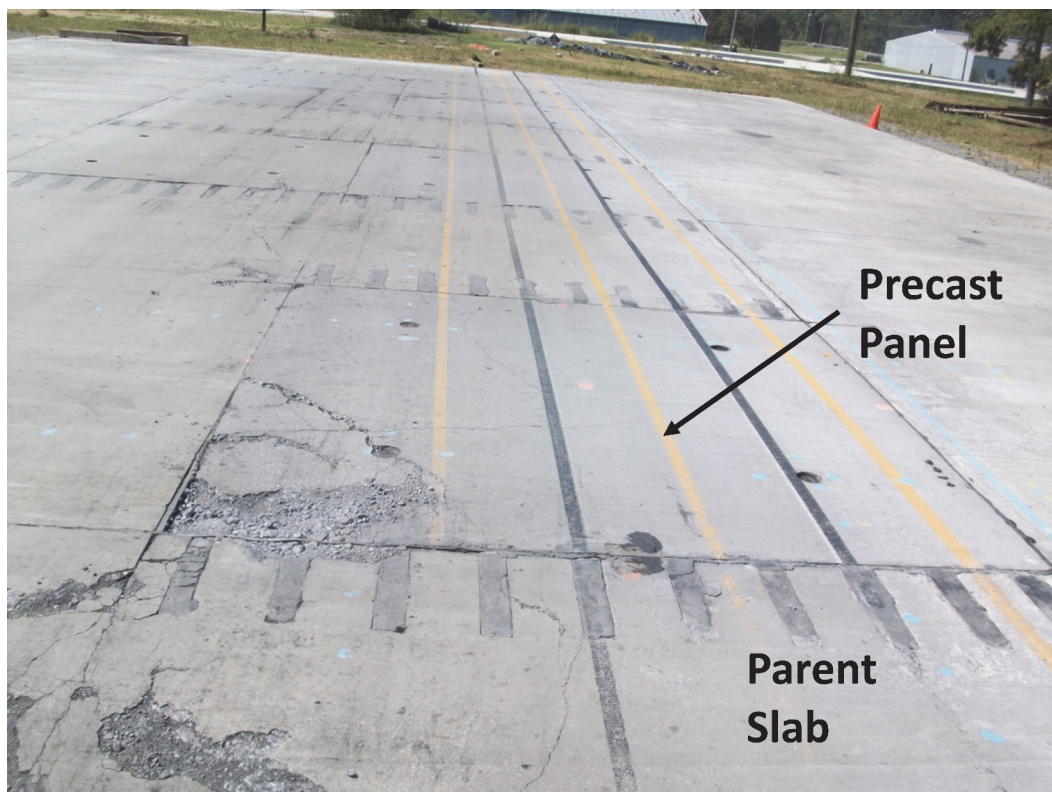
Figure 47. Repair 1 at failure condition.

joints, the initial LTE was approximately 88 percent, but this reduced to 20 percent for the E joint and 78 percent for the W joint after 5,600 passes. For the transverse joints, the LTE met the general PCC guidance of at least

70 percent, indicating that the dowel preparation was acceptable as meeting the requirements for general PCC requiring load transfer.

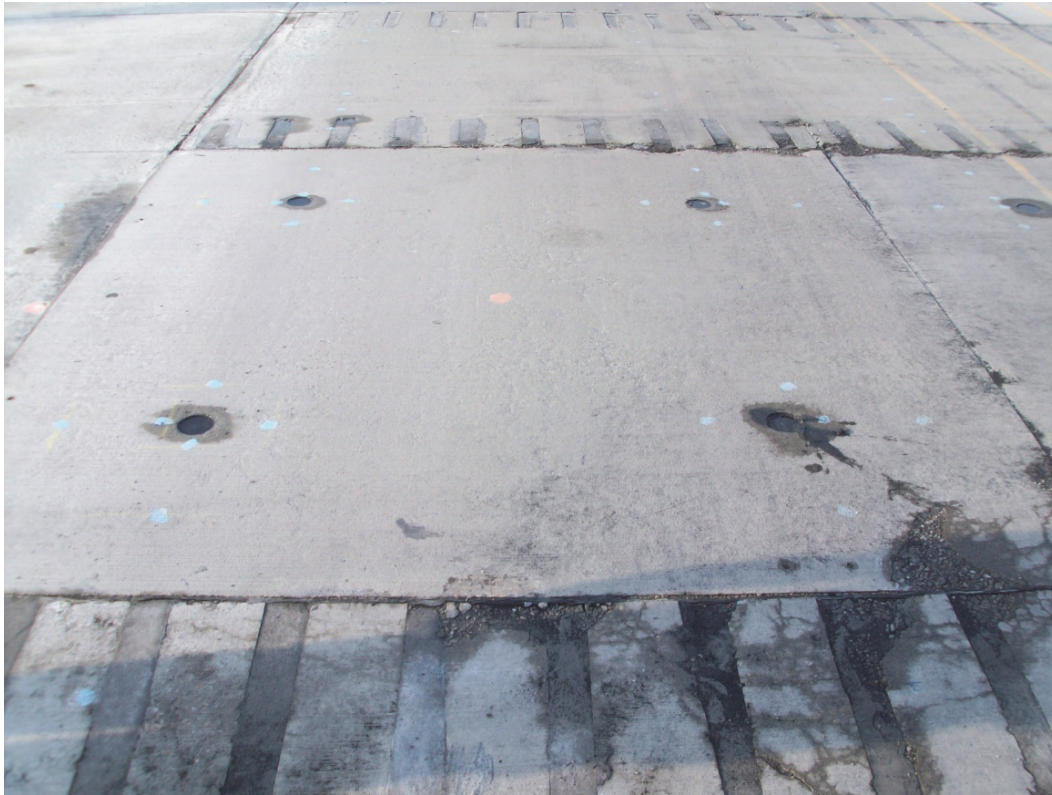
Figure 48. Repair 2-Panel 2 at failure condition.

80 percent. The LTE increased from 54 percent to 85 percent for the E joint of Panel 2, indicating that the joint had better LTE possibly due to expansion or movement of a panel. The E and W joints of Panel 3 also increased in LTE from the initial measurement, most likely also due to expansion or movement of the panels causing closer contact of the panel to the parent PCC leading to increased LTE. For the transverse joints, the LTE prior to traffic met the general PCC guidance of at least 70 percent, indicating that the dowel preparation was acceptable as meeting the minimum requirements for general PCC requiring load transfer. After 10,000 passes, the S joint of Panel 2 and the N joint of Panel 3 had LTE values less than the minimum requirement.

The maximum panel center deflection measured following 10,000 passes was 17.41 mils for Panel 2 and 17.44 mils for Panel 3, which were small increases from the initial deflection measurements of 12.21 and 12.34 mils, respectively. The corner deflections of Panel 2 showed an increase from 19.5 to 52.93 mils at failure. The initial peak center deflections from these panels were similar to the other panels with a range of 12 to 15 mils.

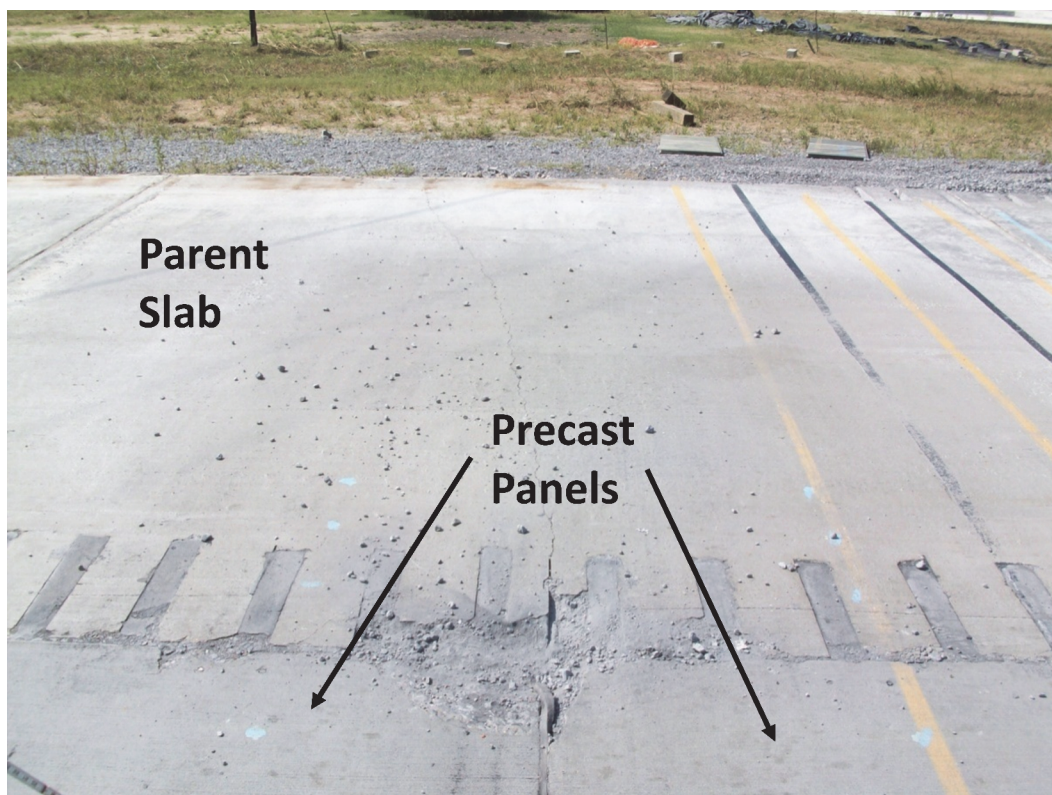
Figure 49. Repair 3 South edge at failure condition and cracking extending from overcut in parent slab.

The roughness criteria were not exceeded for this repair with a maximum recorded elevation difference of 0.375 in. from the installation elevation. The maximum elevation measurement was 0.625 in. along the NE corner of Panel 4.

As can be seen in Table 7, the LTE decreased from installation to failure for Repair 3 from a range of 90 to 96 percent for the transverse joints (N and S) down to approximately 55 to 92 percent. The largest decrease was measured for Panel 7 on the S edge of the repair. This is not unexpected by the severity of the spalling and cracking on this side of the repair. For the longitudinal joints, the initial LTE ranged from 44 to 95 percent. The lowest LTE was for the E joint of Panel 6 of 44 percent. The panels decreased from their initial
